## Green Building Case Study: First Congregational United Church of Christ, Ashland, *A house where love can dwell and all can safely live*

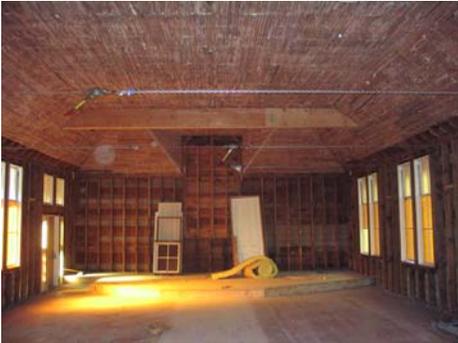
The sanctuary in progress.

So the building was raised and the foundation rebuilt. Then the building was lowered onto a new floor, and the roof lifted off. Because the church was built on a slope, the sagging walls were not square; all the corners were cut off and replaced and the walls realigned to building code standards. The roof then was put back into place, the beams and rafters straightened and “sistered” with reinforcements. In the gutted walls still remain the original studs, with new reinforcing studs, insulation, and shear panels (shear panels are nailed in a specific way to counter the effects of lateral loads acting on a structure). The roof and walls were fully insulated, reducing the church’s output of greenhouse gasses by
